**Re: Dakota Access, LLC
Case No. PU-14-842**

To: Mike Futch, Dakota Access, LLC

From: Ben Cashman
Craig Erdman
Jon Robison, PE

Subject: MP 16.5 Drainage Feature, Vicinity of Little Missouri River Crossing,
Dakota Access Pipeline Project, North Dakota

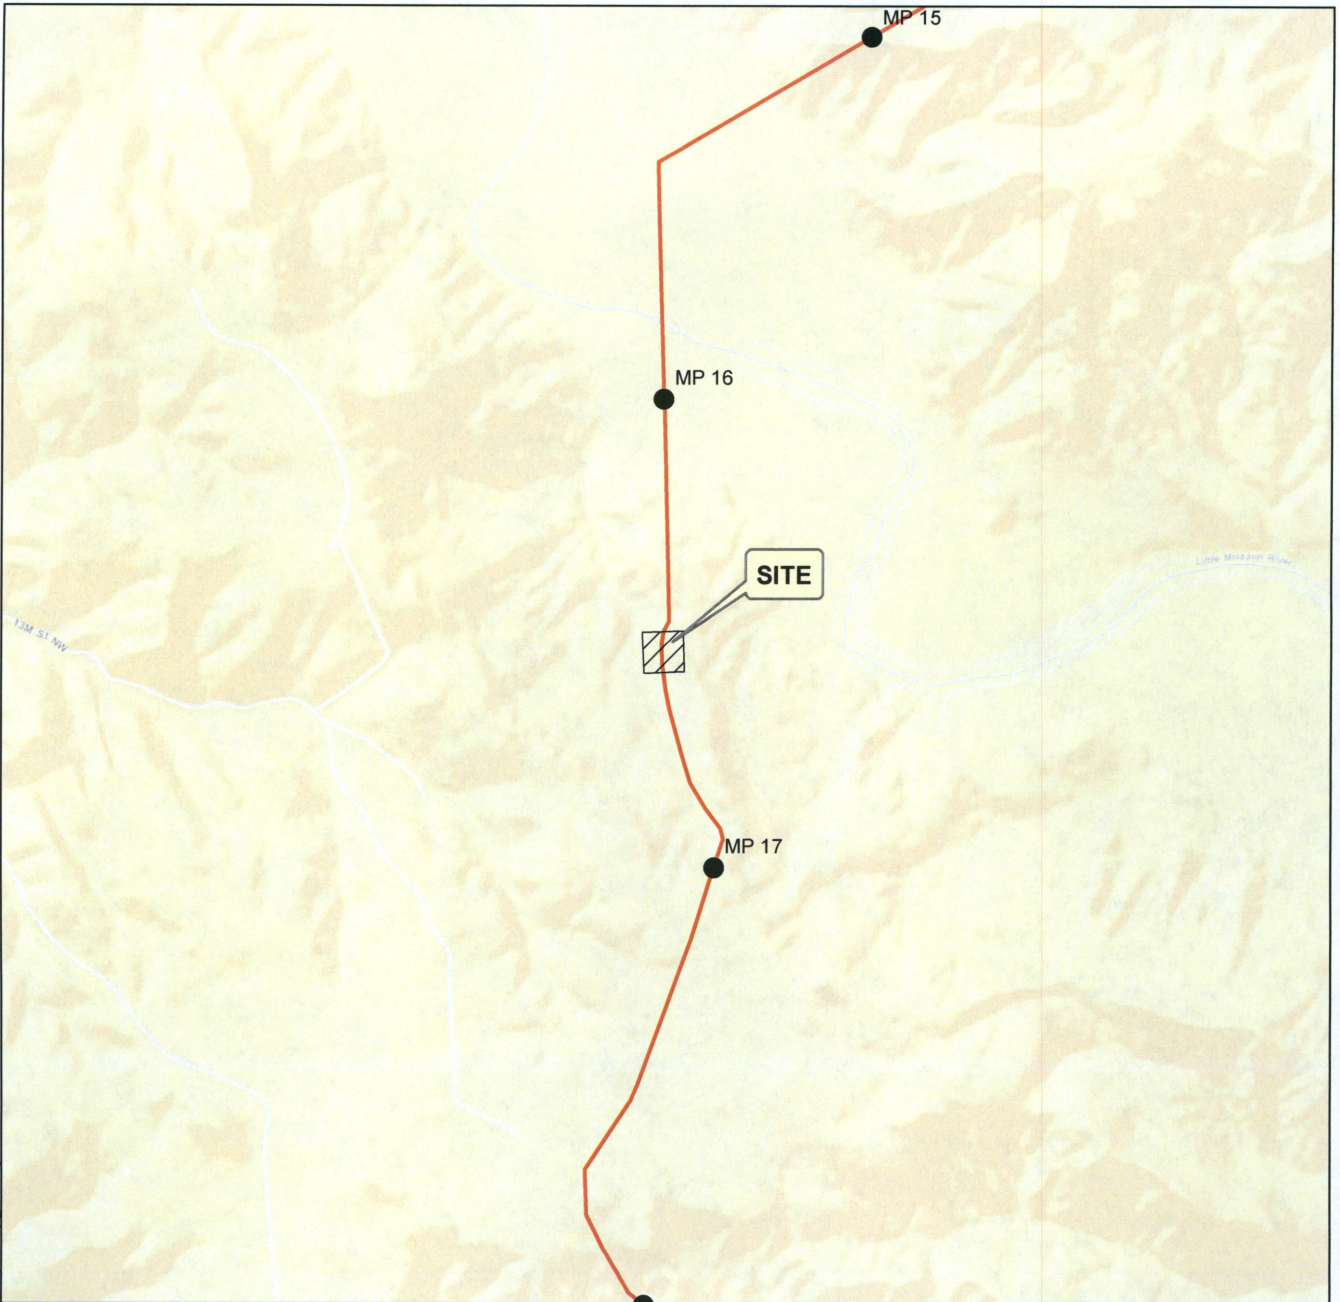
Figure 1

Vicinity Map

Drainage Feature MP 16.5
 Proposed DAPL Main Line
 Dunn County, North Dakota

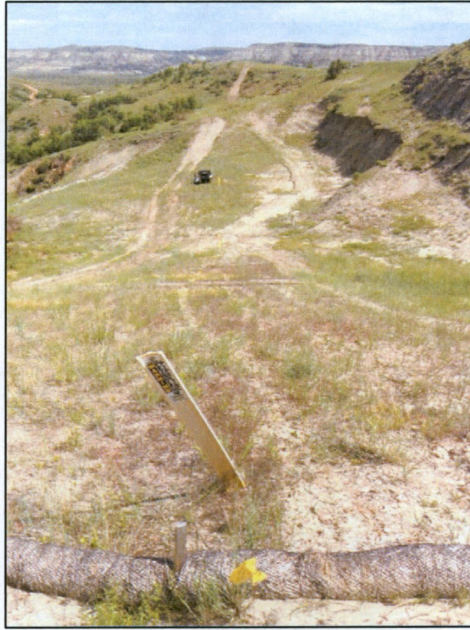
Photograph 1. Vantage of regraded fill area along existing Bridger Four Bears pipeline. View to north.

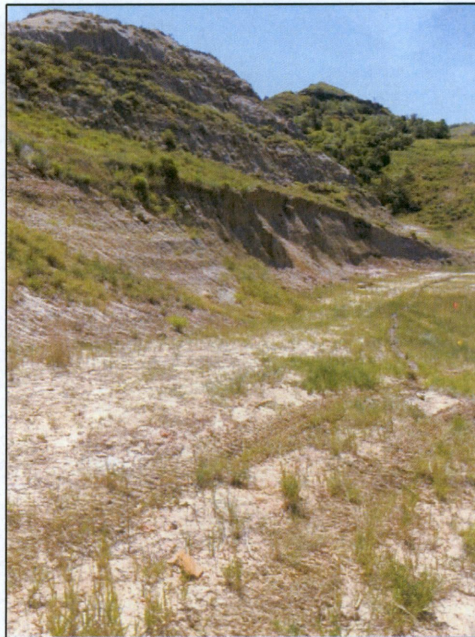
We observed the headscarp of the 2011 slope failure event that exposed the DGC and Bridger pipelines. The scarp is near vertical, approximately 280 feet long and is approximately 25 feet tall above the existing regraded fill surface. The northern portion of the scarp has been regraded to 65 percent.

Photograph 2. Scarp of 2011 "cave-in" event, with bedrock butte on photo left. View to south.

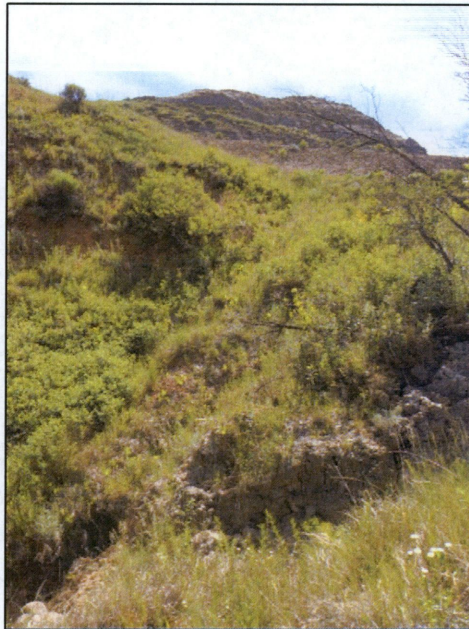
Photograph 3. Vantage from lower stream drainage looking up at natural bedrock buttress (photo left) and bedrock butte (top of photo). View to east.

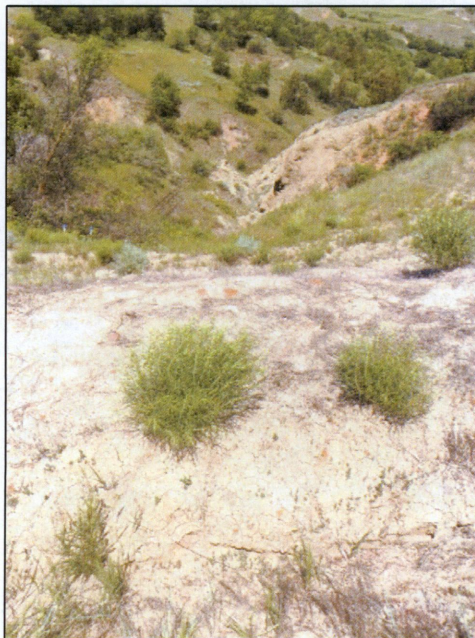
Photograph 4. View from lower butters berm to lower stream drainage, with natural bedrock buttress on photo right. View to west.

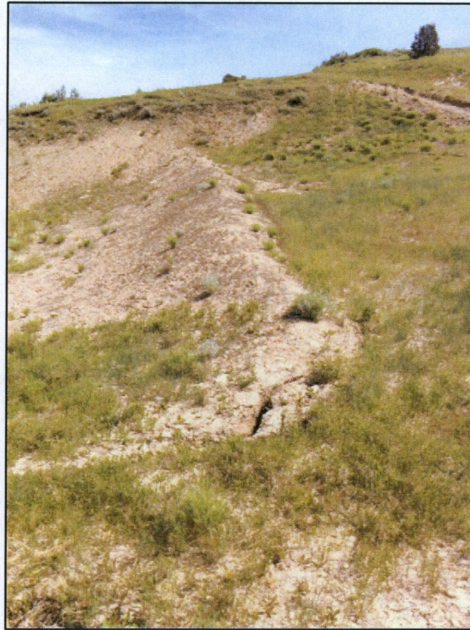
Photograph 5. Upper berm area. View to north

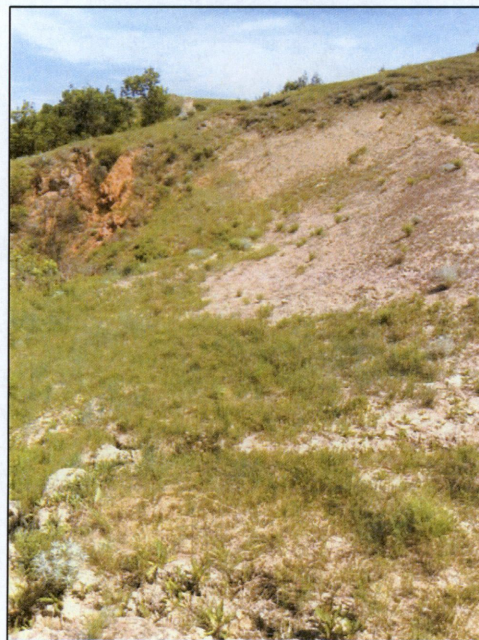
The lower fill berm is approximately 110 feet long and rises about 8 feet above the native underlying topography downstream. The outboard slope of the lower berm is inclined to approximately 50 percent, and the berm crest plunges at approximately 10 percent to the south-southwest. The upper berm is about 205 feet long and rises approximately 10 to 12 feet above the lower berm. The outboard slope of the upper berm is inclined to about 55 percent. The inboard slope of the berm is about 2 feet tall, and the fill slope rises to the southeast (upslope) of the berm and is uniformly inclined to about 20 percent. The material used to construct the fill berms is gray sandy silt that appears to be derived from the local soil and soft bedrock excavated from elsewhere on site. We did not observe evidence that granular drainage layers or other imported materials were used underneath the silty sand fill.

Photograph 6. Upper berm area (photo right) and lower berm (photo left). View to north.

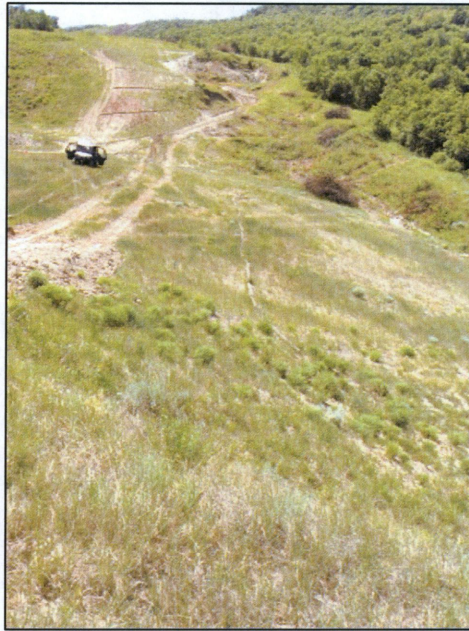
Photograph 7. View across regraded fill area along proposed DAPL centerline (marked by stakes). View to south.

Based on our field observations of the height of the upper buttress berm above the lower natural bedrock buttress downslope to the west (an elevation difference of about 12 to 15 feet), the fill is likely about 15 feet thick above the underlying native slope in this area. Depending on the nature of the underlying topography that was present before the fill was placed (such as possible stream channels or other irregularities in the surface that were buried), it is possible that the fill locally exceeds 20-25 feet in some areas. The potential for the time-independent risk to the Dakota Access pipeline associated with the existing fill may be reduced by installing the pipeline in the native soil/bedrock that underlies the fill.

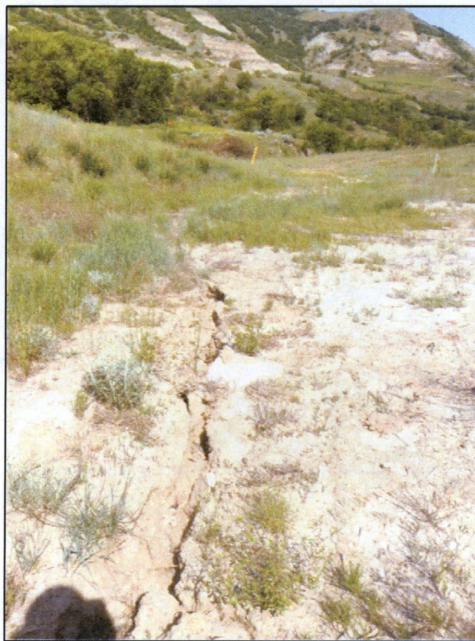
Photograph 8. Incising stream channel across eastern edge of ROW fill. View to northwest.

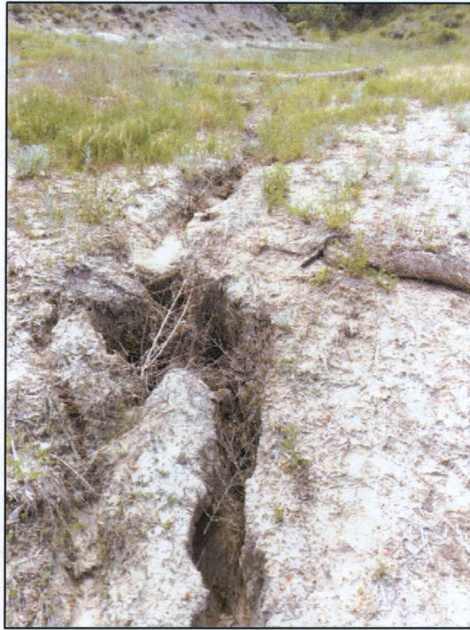
The abundant evidence of actively incising stream channels cutting into the fill along the southern and western margins of the fill is of concern for the existing Bridger Pipeline, as these channels have abrupt nickpoints that appear to be migrating headward towards the Bridger line. If left unaddressed by Bridger, these channels and new channels may create a time-independent risk for the fill in the vicinity of the proposed Dakota Access pipeline.

Photograph 9. Headward-migrating nickpoint in incised stream channel on western edge of ROW fill. View to southeast.

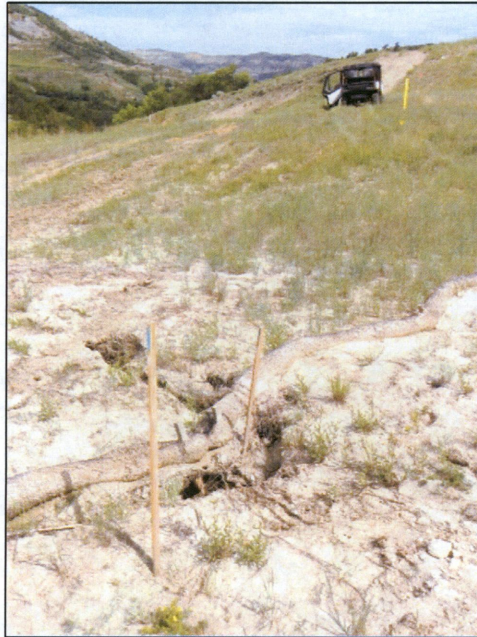
Photograph 10. Incising stream channel in vicinity of Four Bears line. View to northwest.

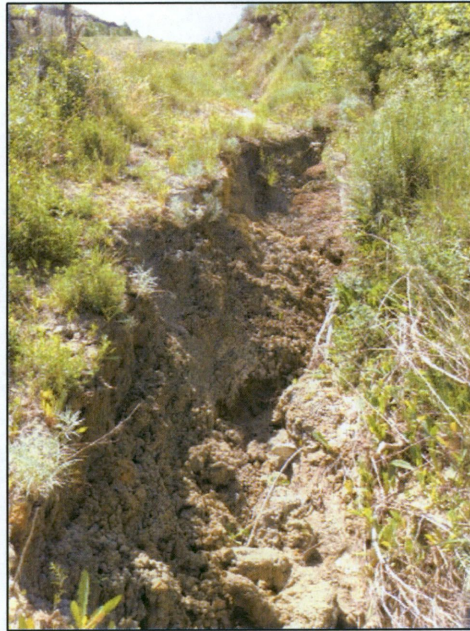
In general, the channel becomes increasingly more incised (up to 5 feet deep) as it continues northwestward along the west boundary of the fill. The channel then makes a sharp bend to the right (northeast) near the northwestern extent of the fill and increases in depth to approximately 7 feet. The channel meanders back to the left (northwest) downgradient of the natural rock buttress. An abrupt nickpoint is migrating headward in the channel from the west side of the ROW towards the Bridger line. We observed two small tributary channels incised into the fill area, one of which originates at the downslope end of the upper fill berm. We observed a 6-inch-diameter corrugated plastic drain pipe daylighting into the main stream channel in this vicinity. The drain pipe was partially filled with sediment and was not producing any flow at the time of our visit. The source or intended function of the drainpipe is unknown. We did not observe any other drainage pipes or structures at the site.

Photograph 11. Incising channel along western margin of fill area. View to southeast.

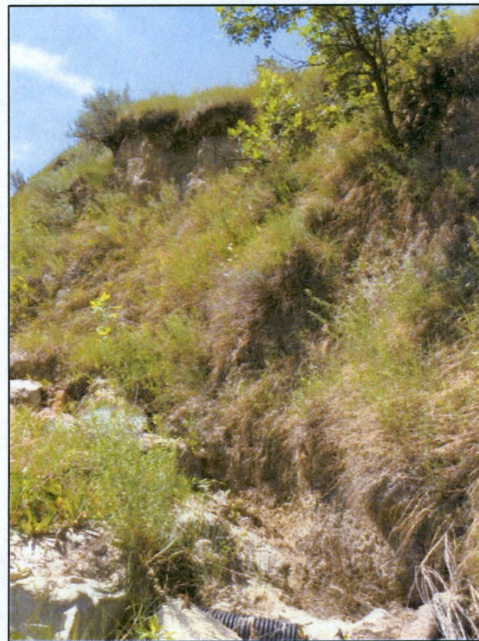
Photograph 12. 12-foot-tall embankment along western margin of fill area. CMP drainpipe at bottom of photo. View to south.
